**Flood Control Project Maintenance  
Levee Inspections**

**Maintenance Issue Types Only, Levee Inspection Report By Mile - Fall 2018**

**Sutter Maintenance Yard Maintenance Area 0005**

Waterway	Bank	Unit Miles	Inspection Start/End	Inspector
Unit No. 01 Butte Creek	Left	15.08	10/30/2018 10/30/2018	Bob Duffey

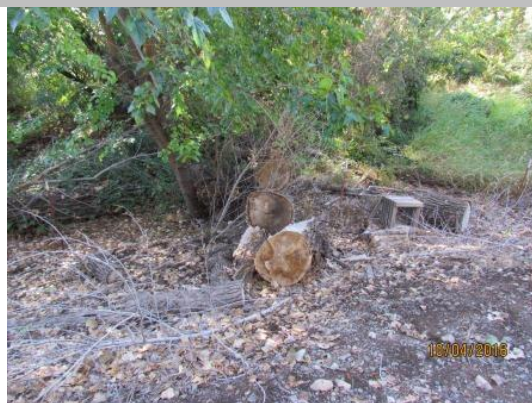
Photo 1 of 1 : FA\_2018\_MA0005\_196\_45\_20180905\_00022.jpg

LM Start	0.05	Rating **	M	Issue No.	45
LM End	0.05	Issue Type +	Ma	Location *	LS
Category	Earthen Levee			GPS Latitude/Longitude	
				Start	End
Item	Trim / Thin Trees			39.696790 °	39.696790 °
				-121.774154 °	-121.774154 °
DWR ID	DWR_MA0005_01_f_2016_45				
Comment Code					
T1 : Trim trees to at least five feet above ground level.					
Inspector Comment					
Remove wood logs from the waterside slope and trim trees to at least five feet above the levee slope.

View of the wood logs on the landside slope.

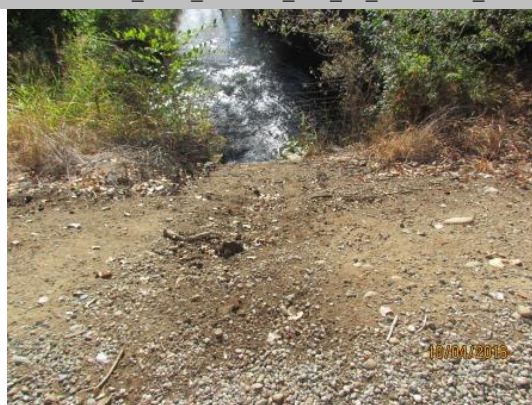
Photo 1 of 1 : FA\_2018\_MA0005\_196\_46\_20180905\_00023.jpg

LM Start	0.07	Rating **	M	Issue No.	46
LM End	0.07	Issue Type +	Ma	Location *	LS
Category	Earthen Levee			GPS Latitude/Longitude	
				Start	End
Item	Slope Stability			39.696611 °	39.696611 °
				-121.774349 °	-121.774349 °
DWR ID	DWR_MA0005_01_f_2016_46				
Comment Code					
S2 : Repair the levee slope damaged by foot traffic and prevent access where possible.					
Inspector Comment

View of the damaged slope by foot traffic.

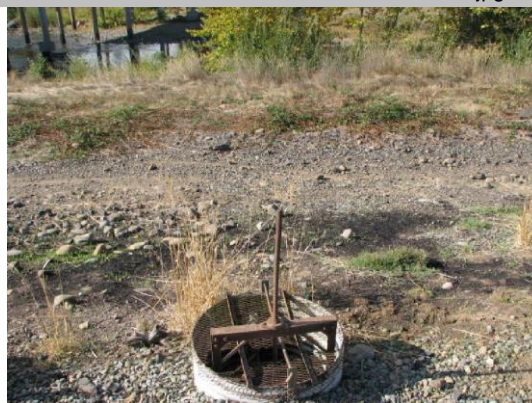
Photo 1 of 3 : UCIP\_FA\_2018\_51949\_67931.jpg

Comment Code						
Inspector Comment						
FS_ID:51949						
DS_ID:1616						
EP_NO: N/A						
Repair Type: No Action Needed						
Crossing Status: Found						
UCIP Comments: 5/15/2017 Crossing appears to be in good condition.						
LS inlet is located in the Distribution box on the LS toe. This is an						
overflow pipe used to regulate water levels in side the box. Pipe has						
been selected to be internally cleaned and inspected as part fo the						
DMP project. (DWR Sutter Yard- AFreitag)11/15/2016 Crossing						
appears to be in good condition. (DWR Sutter Yard-						
AFreitag)5/9/2016 Crossing appears to be in good						
condition.8/5/2015 WS pipe end is being overgrown by trees and						
other vegetation. Needs to be cleared back.12/8/2014 Same as last						
inspection.6/11/2014 Same as last inspection.11/20/2013 Same as						
last inspection.5/29/2013 Same as last inspection.						
FIELD_STRUCT_DESC: 24-inch corrugated metal drainage pipe

CMP riser and slide gate on WS shoulder.

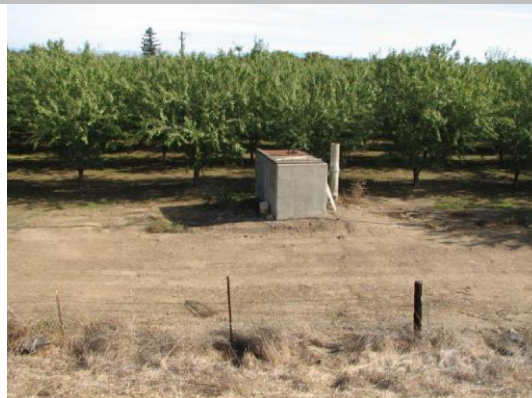
Photo 2 of 3 : UCIP\_FA\_2018\_51949\_67930.jpg

Item	DWR UCIP LMA Responsibility			39.646217 °	39.646217 °	
				-121.785431 °	-121.785431 °	
DWR ID	1616					
Comment Code						
Inspector Comment						
FS_ID:51949 DS_ID:1616 EP_NO: N/A Repair Type: No Action Needed Crossing Status: Found UCIP Comments: 5/15/2017 Crossing appears to be in good condition. LS inlet is located in the Distribution box on the LS toe. This is an overflow pipe used to regulate water levels in side the box. Pipe has been selected to be internally cleaned and inspected as part fo the DMP project. (DWR Sutter Yard- AFreitag)11/15/2016 Crossing appears to be in good condition. (DWR Sutter Yard- AFreitag)5/9/2016 Crossing appears to be in good condition.8/5/2015 WS pipe end is being overgrown by trees and other vegetation. Needs to be cleared back.12/8/2014 Same as last inspection.6/11/2014 Same as last inspection.11/20/2013 Same as last inspection.5/29/2013 Same as last inspection. FIELD_STRUCT_DESC: 24-inch corrugated metal drainage pipe through the levee, 16.5 feet below the crown. Slide gate in a corrugated metal riser on the waterside (WS) slope. Flap gate on the WS toe. Inlet on the landside (LS) toe, not found. [Additional Reference(s): DWR Levee Log, 1990. USACE Sacramento O&M Manual 516, April 1960, (Station 381+36)]. FS Date: 5/31/2017 12:32:00 PM

Unable to locate inlet on LS.

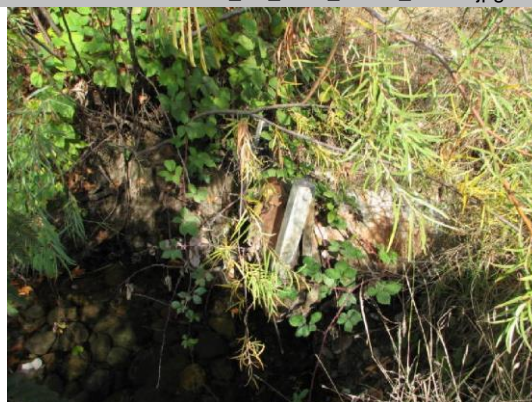
Photo 3 of 3 : UCIP\_FA\_2018\_51949\_67929.jpg

Flap gate in channel at WS toe.

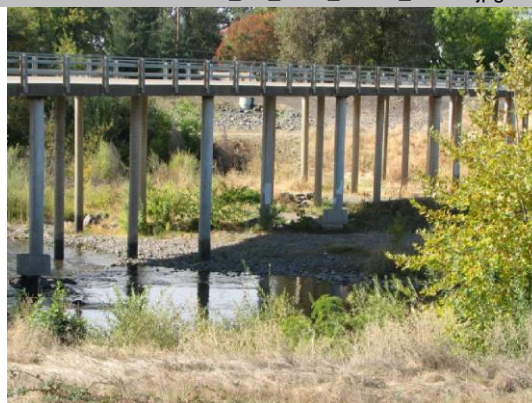
Photo 2 of 3 : UCIP\_FA\_2018\_51950\_67933.jpg

CMP riser at other end of siphon on south west side of bridge.

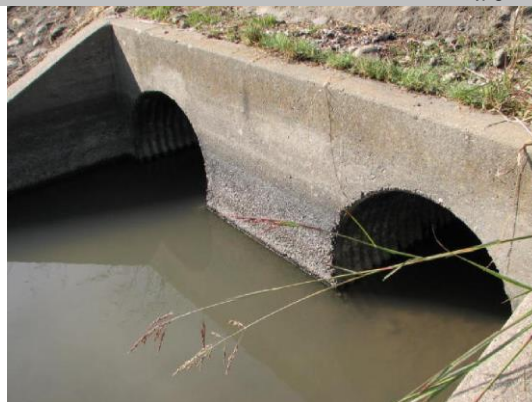
Photo 2 of 3 : UCIP\_FA\_2018\_51954\_67938.jpg

FS\_ID:51954  
DS\_ID:1768  
EP\_NO: N/A  
Repair Type: Non-Urgent  
Crossing Status: Found  
UCIP Comments: 5/15/2017 Abandoned and needs to be done properly. A sink hole formed in the WS toe road and revealed the location of the WS pipe end. Sink hole will need to be repaired before the next high water season but the pipe has been selected to be internally cleaned and camera inspected as part of the DMP project so it will have needed to be excavated along the WS end anyways. (DWR Sutter Yard- A/Freitag)11/15/2016 Abandoned. Needs standpipe cover. (DWR Sutter Yard- A/Freitag)5/9/2016 Abandoned pipe. Needs a cover for standpipe.8/5/2015 Abandoned pipes. Need covers made for tops of standpipes to prevent falls. 12/8/2014 Same as last inspection.6/11/2014 Same as last inspection.11/19/2013 Same as last inspection.5/29/2013 Same as last inspection. Land owner said pipes are abandoned and no longer used. Covers should be made for top of standpipe to prevent falls. Pipes should be properly abandoned.10/30/2012 Pipe 1/2 filled with soil at slide gate on WS. FIELD\_STRUCT\_DESC: \*ABANDONED\* 2 of 2: 36-inch corrugated metal drainage pipe through the levee, 11 feet below the crown. Slide gate in a 54-inch corrugated metal riser on the waterside (WS) slope. Concrete "U" shaped headwall on the landside (LS). [Additional Reference(s): DWR Levee Log, 1990. Sacramento O&M Manual 516, April 1960, (Station 470+00)].

Headwall at LS toe.

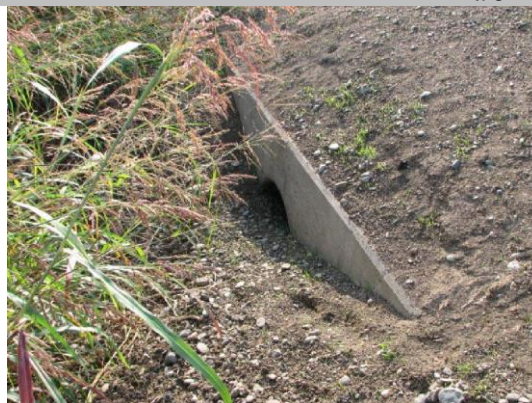
Photo 2 of 2 : UCIP\_FA\_2018\_51970\_67969.jpg

Comment Code					
Inspector Comment					
FS_ID:51970					
DS_ID:1628					
EP_NO: N/A					
Repair Type: Non-Urgent					
Crossing Status: Found					
UCIP Comments: 5/16/2017 LS inlet is almostc ompletely buried.					
Nothing visible on the WS. Pipe has been selected to be internally					
cleaned and inspected as part of the DMP poject. (DWR Sutter Yard-					
AFreitag)11/15/2016 Appears abandoned and should be done so					
properly. (DWR Sutter Yard- AFreitag)5/11/2016 Possibly an					
abandoned crossing. LS inlet was over 50% buried and nothing was					
found on the WS.8/4/2015 LS pipe end filled about 50% with soil and					
WS pipe end is buried.12/8/2014 Same as last					
inspection.6/11/2014 Same as last inspection.11/19/2013 Same as					
last inspection.5/29/2013 Same as last inspection.10/30/2012 Pipe					
filled with soil and outlet/appurtances are burried.					
FIELD_STRUCT_DESC: *ABANDONED* 24-inch corrugated metal

Headwall at LS toe.

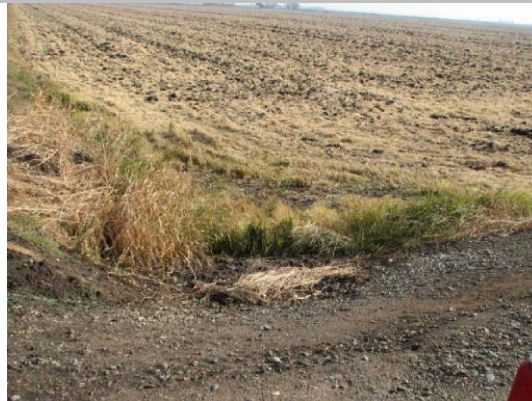
Photo 2 of 3 : UCIP\_FA\_2018\_51972\_67972.jpg

Comment Code						
Inspector Comment						
FS_ID:51972 DS_ID:1629 EP_NO: N/A Repair Type: Non-Urgent Crossing Status: Found UCIP Comments: 5/16/2017 LS inlet is half blocked off by flash boards and sediment. WS flap gate is blocked closed by sediment. Pipe has been selected to be internally cleaned and inspected as part of the DMP project. (DWR Sutter Yard- AFreitag)11/15/2016 LS inlet was unburied and entire pipe is about 25% full of soil. WS flapgate was shut and partially buried. (DWR Sutter Yard- AFreitag)5/11/2016 WS flap gate was about 50% buried and LS was 100% buried. Appears to be an abandoned crossing.8/4/2015 WS flap gate is partially buried by soil and being overgrown with vegetation. LS pipe end was underwater and suspected to still be completely buried with soil.12/8/2014 Same as last inspection.6/11/2014 Same as last inspection.11/19/2013 Same as last inspection.5/29/2013 Same as last inspection.10/30/2012 Pipe filled with soil. FIELD_STRUCT_DESC: 24-inch corrugated metal drainage pipe through the levee, 9.3 feet below the crown. Flap gate on the waterside (WS). Concrete headwalls at the landside (LS) and the WS toes. [Additional Reference(s): DWR Levee Log, 1990. USACE Sacramento O&M Manual 515, April 1955, (Station 609+79). USACE As-Built Drawing No. 50-4-2637, Exhibit B, Sheet 3, April 1950, (Station 609+78.5)]. FS Date: 5/31/2017 1:59:10 PM

Buried inlet at LS toe.

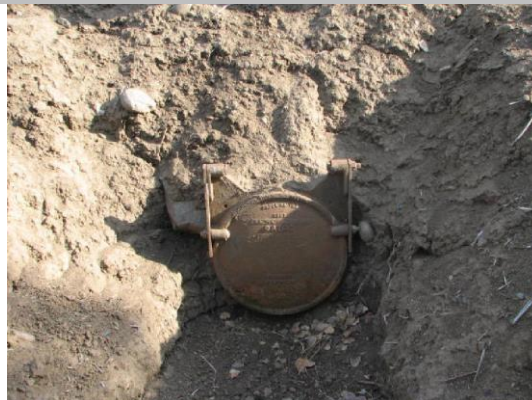
Photo 3 of 3 : UCIP\_FA\_2018\_51972\_67971.jpg

Flap gate at WS toe.

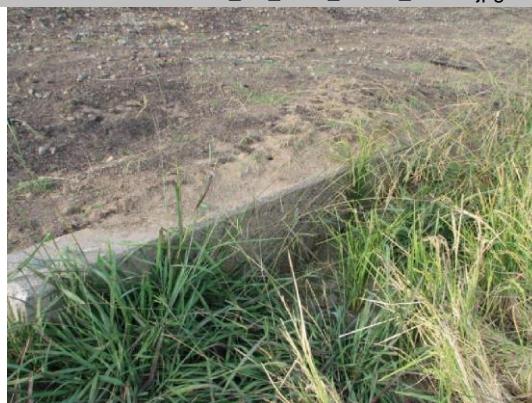
Photo 2 of 2 : UCIP\_FA\_2018\_51982\_67990.jpg

Comment Code					
Inspector Comment					
FS_ID:51982					
DS_ID:1635					
EP_NO: N/A					
Repair Type: Non-Urgent					
Crossing Status: Found					
UCIP Comments: 5/16/2017 Abandoned- needs to be done so properly. (DWR Sutter Yard- A Freitag)11/15/2016 Abandoned. (DWR Sutter Yard- A Freitag)5/11/2016 Abandoned crossing.8/4/2015 Abandoned pipe. Casey Wilder has started the steps to have the pipe properly abandoned and removed from the levee.12/8/2014 Same as last inspection.6/11/2014 Same as last inspection.11/19/2013 Same as last inspection.5/29/2013 Same as last inspection.10/30/2012 Pipe buried on both sides of levee.					
FIELD_STRUCT_DESC: *ABANDONED* 30-inch corrugated metal drainage pipe through the levee, 12.2 feet below the crown. Flap gate on the waterside (WS) end. [Additional Reference(s): DWR Levee Log, 1990. USACE Sacramento O&M Manual 515, April 1955, (Station 748+53). USACE As-Built Drawing No. 50-4-2637, Exhibit B, Sheet 4, April 1950, (Station 748+53)].

Concrete headwall at LS toe.

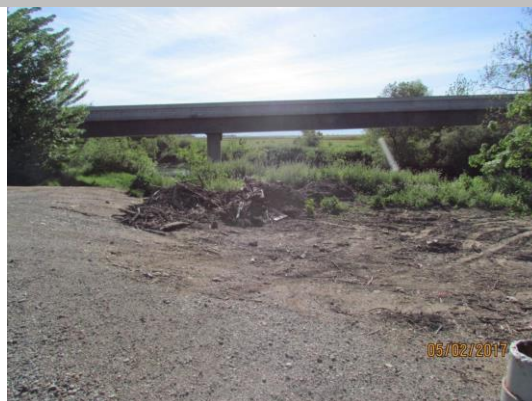
Photo 1 of 1 : FA\_2018\_MA0005\_197\_69\_20180905\_00036.jpg

View of the debris along the waterside toe.

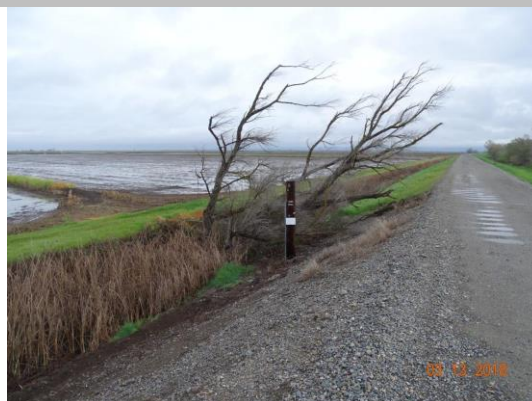
Photo 1 of 1 : FA\_2018\_MA0005\_197\_64\_20180905\_00033.jpg

View of the tree on the landside slope and toe.

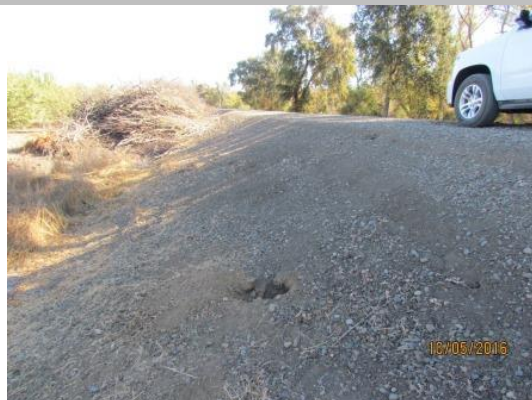
Photo 1 of 2 : FA\_2018\_MA0005\_197\_53\_20180905\_00025.jpg

View of the rodent holes along the landside slope.

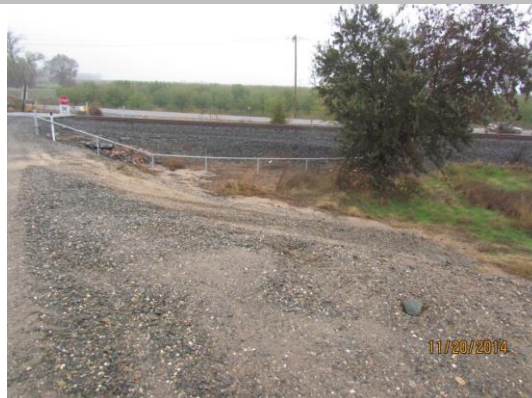
Photo 1 of 1 : FA\_2018\_MA0005\_197\_40\_20180905\_00016.jpg

View of the vehicle slope instability along the landside slope.

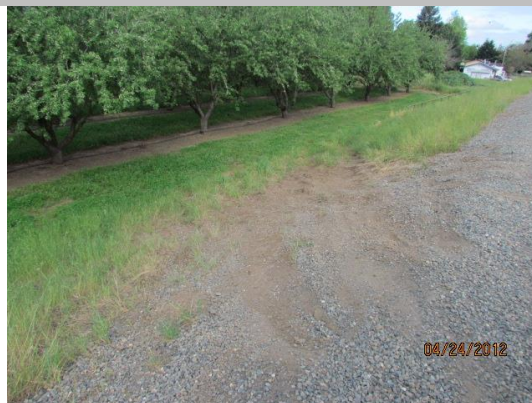
Photo 1 of 1 : FA\_2018\_MA0005\_197\_18\_20180905\_00007.jpg

View of the vehicle erosion along the slope of the levee.

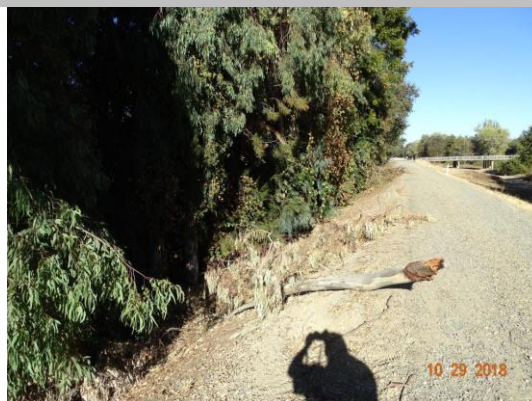
Photo 1 of 1 : FA\_2018\_MA0005\_197\_68\_20181102\_00103.jpg

View of the trees limbs along the landside slope and toe.

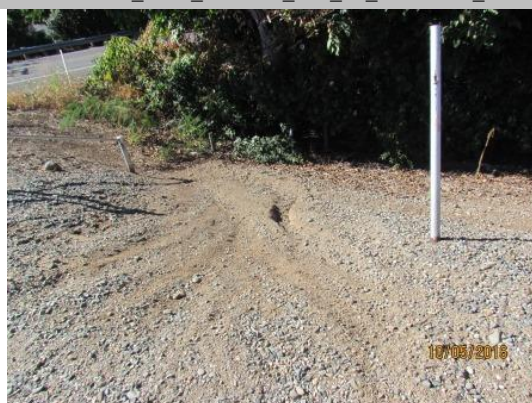
Photo 1 of 1 : FA\_2018\_MA0005\_197\_58\_20180905\_00030.jpg

View of the damaged landside slope.

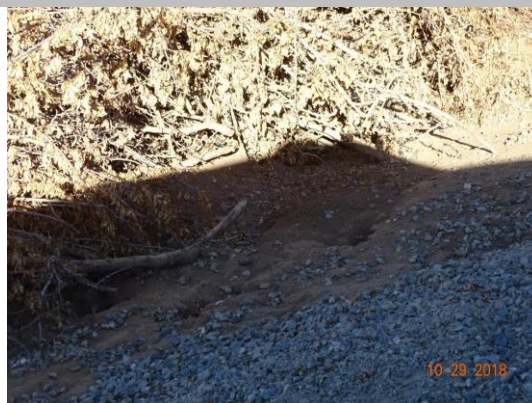
Photo 1 of 1 : FA\_2018\_MA0005\_197\_71\_20181102\_00106.jpg

View of the rodent holes along the landside slope.

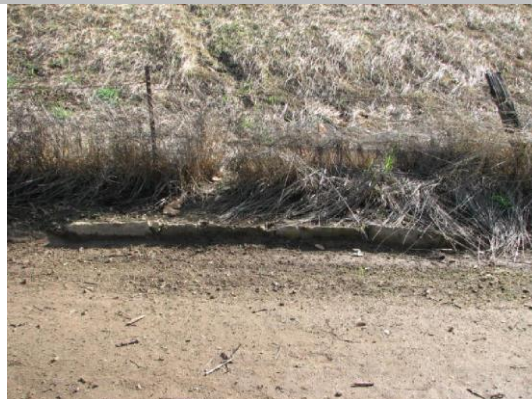
Photo 2 of 3 : UCIP\_FA\_2018\_52072\_68464.jpg

Abandoned headwall on LS toe.

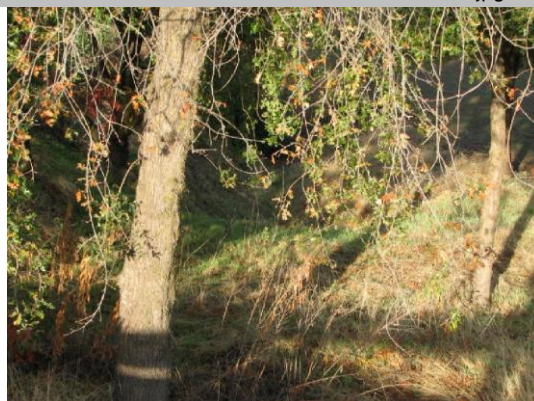
Photo 1 of 3 : UCIP\_FA\_2018\_52083\_68531.jpg

Inlet relocated after bridge replacement away from LS toe.

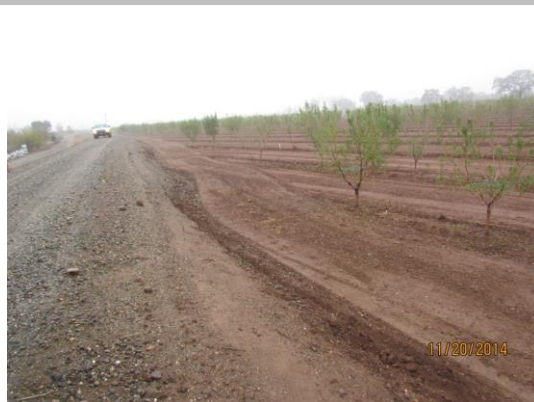
Photo 1 of 1 : FA\_2018\_MA0005\_197\_43\_20180905\_00019.jpg

View of the tilling into the landside slope.

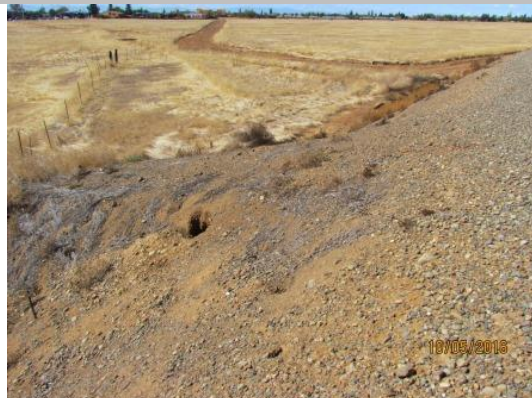
Photo 1 of 1 : FA\_2018\_MA0005\_197\_39\_20180905\_00015.jpg

View of the rodent holes along the landside slope.

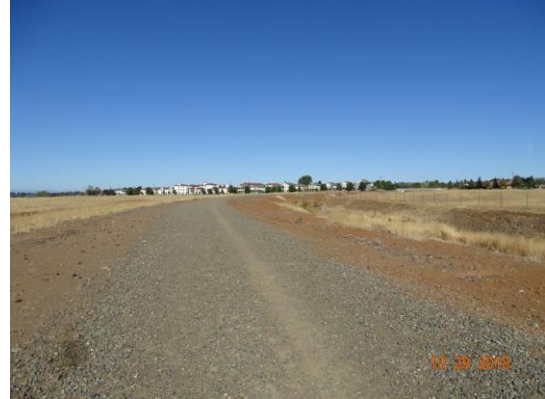
Photo 1 of 1 : FA\_2018\_MA0005\_198\_2\_20181102\_00001.jpg

View of no vegetation on both slopes.
